Status of Efforts Made at Nuclear Power Plants

October 3, 2011

The Federation of Electric Power Companies

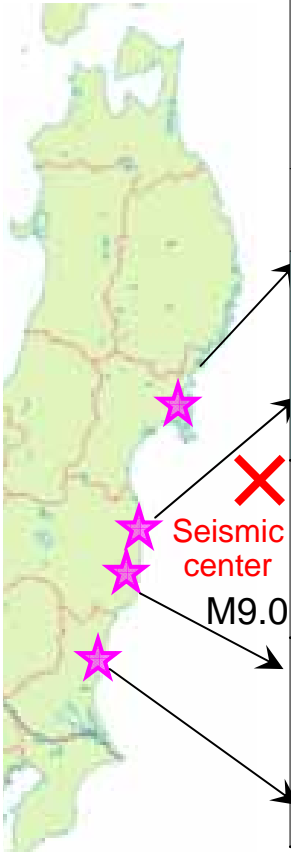
Effects of Great East Japan Earthquake

: Under periodic inspection	Earthquake			Tsunami					Fuel damage
	Power supply		Cooling function	Height (m)	Ground level (m)	Power supply		Cooling function	
	Off-site	Emergency	Seawater pump			Offsite	Emergency	Seawater pump	
Onagawa 1, 2, 3				13	13.8				Sound
Fukushima Dai-ichi 1, 2, 3, 4	×			15.5 (Flooding height)	10 (Units 1-4) 13 (Units 5 & 6)	Earthquake ×	Units 1-5 ×	Units 1-4 ×	Units 1-3 (Damaged) Units 4-6 (Sound)
Fukushima Dai-ni 1, 2, 3, 4				14.5 (Flooding height)	12		Units 1 & 2 ×	Units 1, 2, 4 ×	Sound
Tokai Dai-ni 1	×			5.3	8	Earthquake ×			Sound

Earthquake

- The reactors automatically as required.
- All components required for cooling the reactors functioned properly as emergency DGs automatically actuated in spite of the loss of off-site power.

Tsunami

- Loss of power and cooling function resulted in serious conditions including severe fuel damage.
- Additionally, explosions probably due to hydrogen occurred in the reactor buildings.
- Large amounts of radioactive materials were released into the environment.

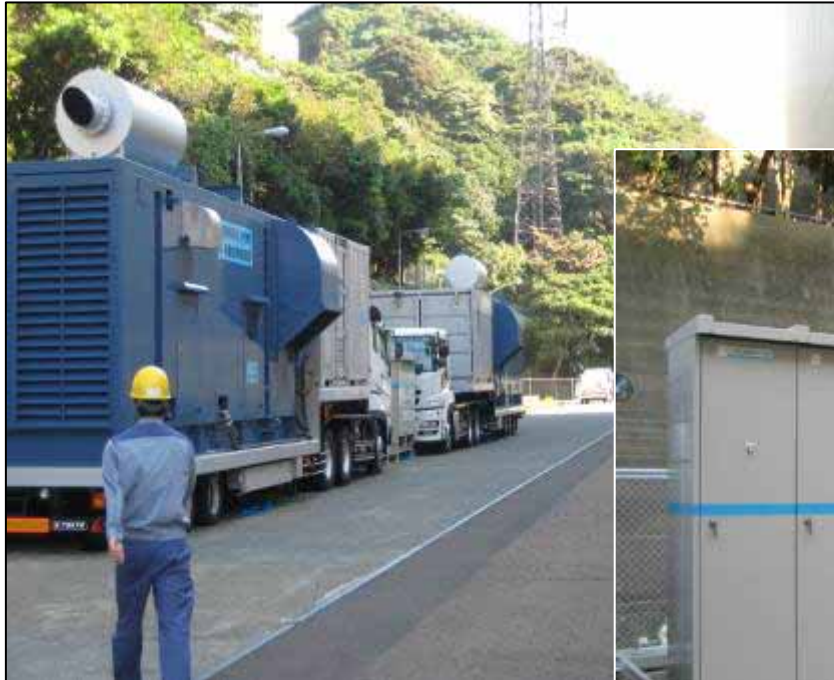
Air-cooled mobile power generators

**Location higher than 30 m
above sea level**

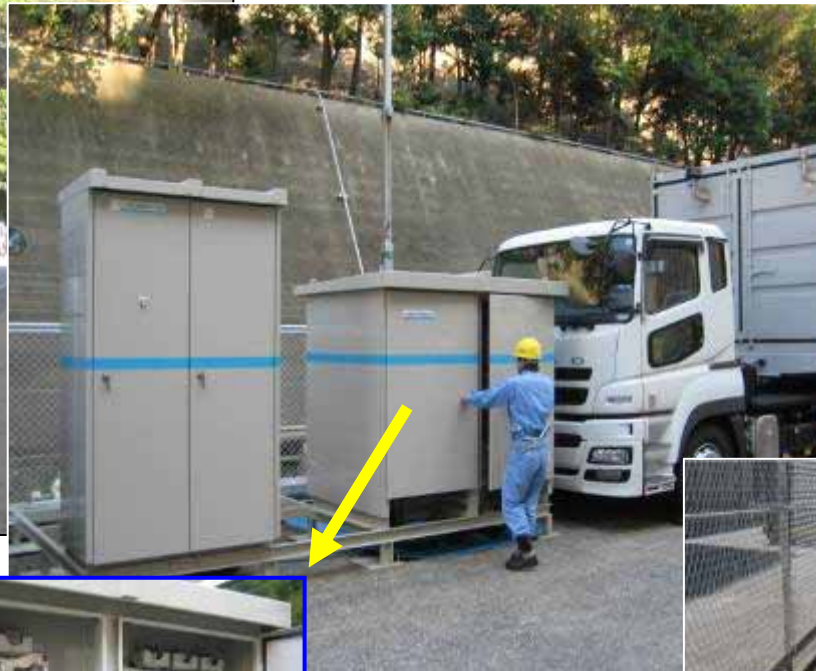
Connection board

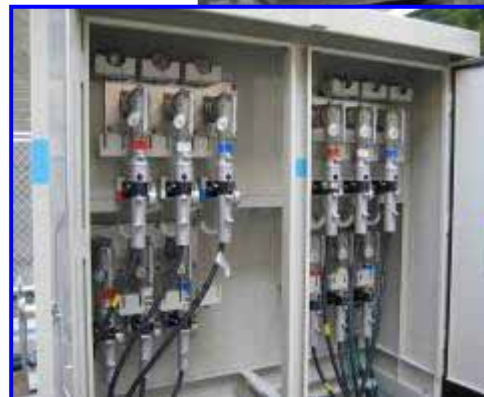
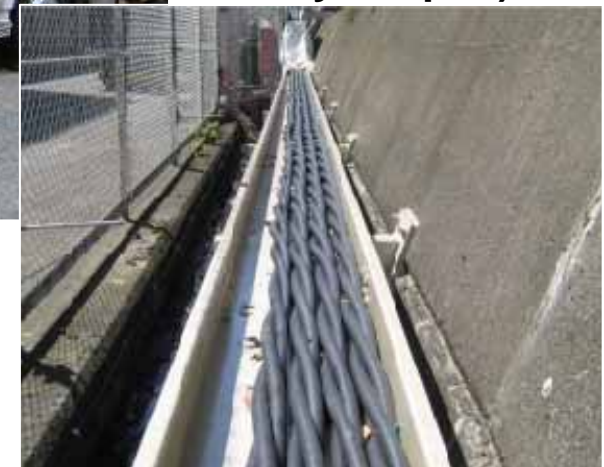
**Installation of cables
(when the lid of the
tray is open)**

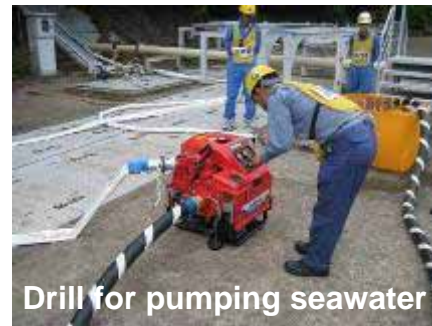
Drill for pumping seawater

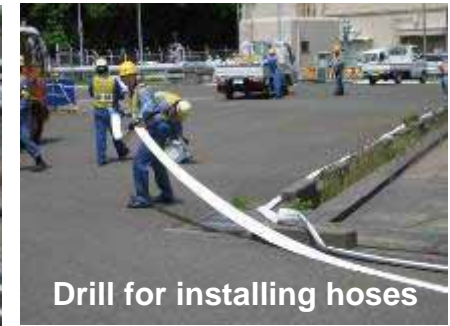
Drill for installing hoses

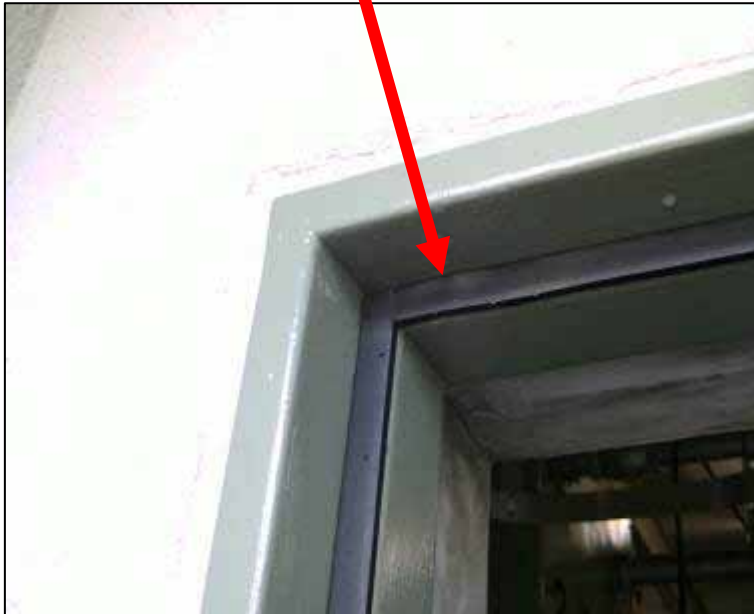
Sealing for the door

Effectiveness of the seal has been proved by manufacturer's tests.

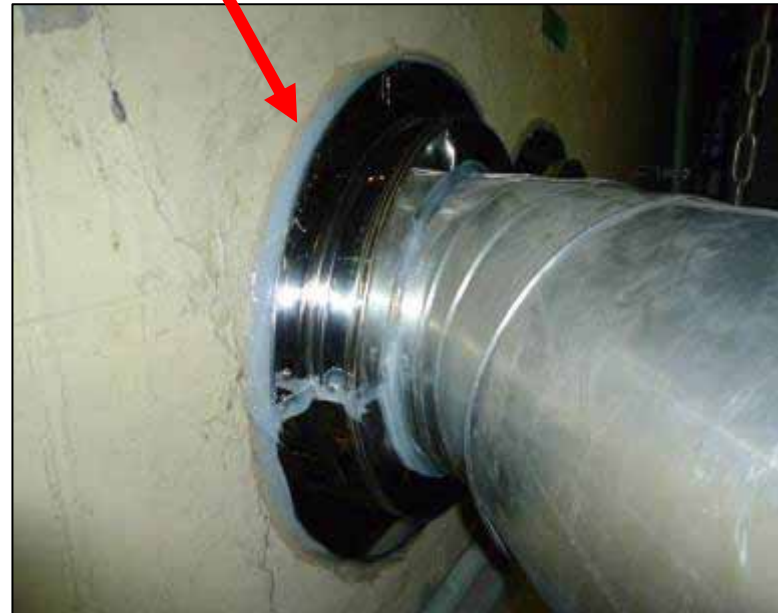
Sealing for pipe penetration part

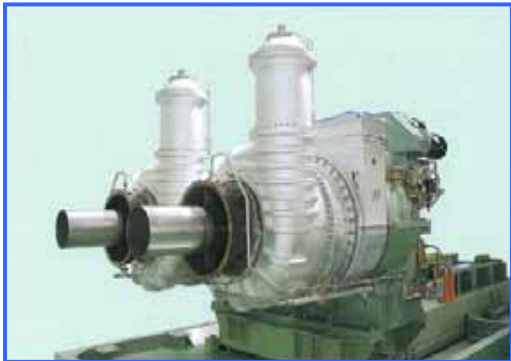
【Addition of permanent emergency power supply units】
(response in the medium- to long-term)

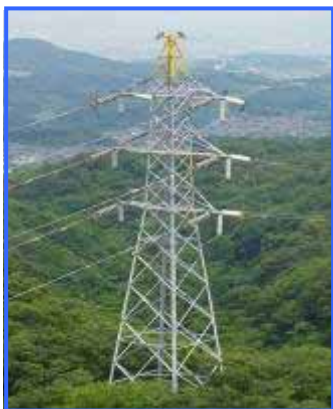
【Reinforcement of transmission lines】
(response in the medium- to long-term)

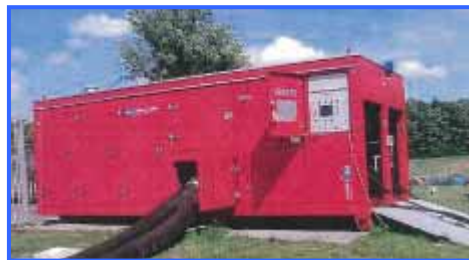
【Deployment of a large-capacity temporary seawater pumps】
(scheduled to be deployed in December 2011)

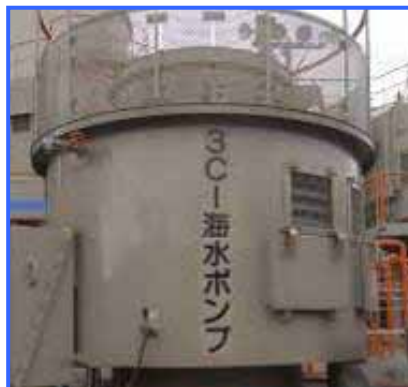
【Deployment of a backup seawater pump motor】
(scheduled to be deployed in March 2012)
